**UPPER PATUXENT RIVER WATERSHED RESTORATION ACTION STRATEGY (WRAS)  
FORM 1 -- Catchment Information**

Subwatershed: Bear Branch

Site Name: Laurel Lakes Executive Park Address: 8301-8387 Cherry Lane

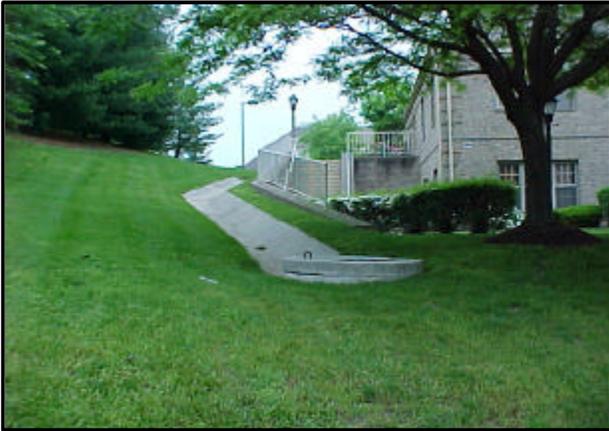
723

No. <u>723</u>	Description: <u>looking north along west side of site</u>
No. <u>724</u>	Description: <u>looking east along south side of site</u>
No. <u>725</u>	Description: <u>looking east across center of site</u>
No. <u>726</u>	Description: <u>looking south along west side of site</u>
No. <u>727</u>	Description: <u>looking east along north side of site</u>
No. <u>728</u>	Description: <u>looking west along north side of site</u>
No. <u>729</u>	Description: <u>looking south along east side of site</u>
No. <u>730</u>	Description: <u>looking west along south side of site</u>
No. <u>731</u>	Description: <u>looking north along east side of site</u>
No. _____	Description: _____

**Comments** Some buildings have downspouts draining directly to conveyance. They can be easily disconnected. Some potential IMP sites are landscaped.

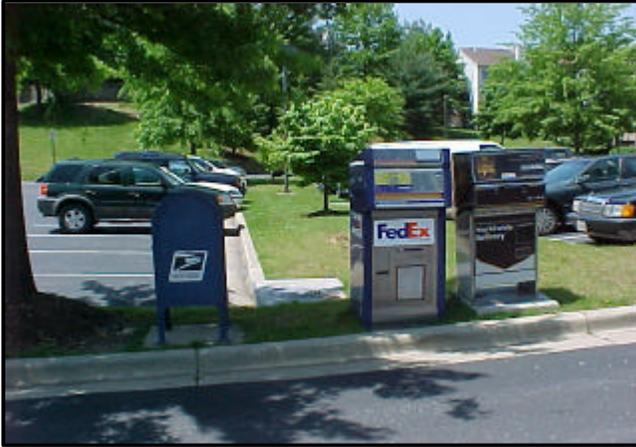
848

No. <u>848</u>	Description: <u>looking west</u>
No. <u>849</u>	Description: <u>looking east</u>
No. _____	Description: _____

**Comments** IMP treat 34% of the drainage area  
IMP size = 1,664 sq ft  
 \_\_\_\_\_  
 \_\_\_\_\_  
 \_\_\_\_\_  
 \_\_\_\_\_  
 \_\_\_\_\_  
 \_\_\_\_\_
